Geotechnical soil conditions and long term deformation- landslide phenomena of Mesochora village, Central Greece.

D. Lambropoulos , *M.Sc Engineering Geology, Head of Geological Subsector, Direction of Hydroelectric Production, Public Power Corporation, Greece, di.lampropoulos@dei.com.gr*

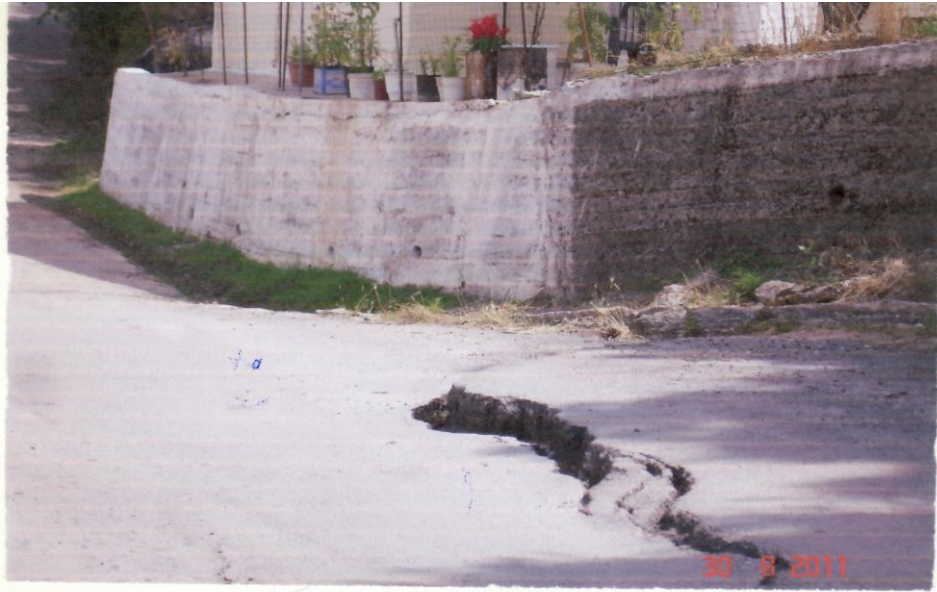
Photo 1 Subsidence-tensional cracking in Mesochora main road

over the maximum elevation of the future reservoir. Long term deformation in the area, in the form of deep creeping is clearly evident through subsidences and tensional cracking observed in the road passing through the village (photo 1) as well as from road walls cracking, tree trunks bending and morphological features of successive flat areas in the village slopes

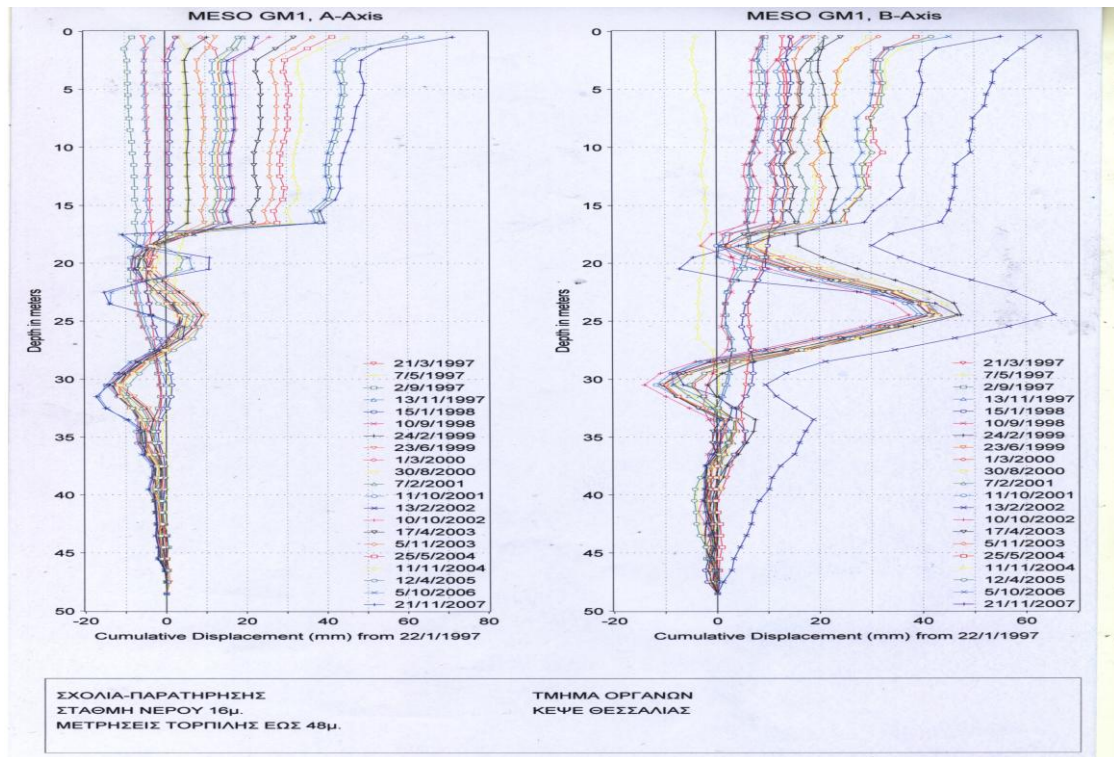
Figure 3. Mesochora village sheared inclinometer (sector B)

monuments(fig.2), along with a network of inclinometers. Most of the instrumentation showed displacements during the last 15 years and 8 inclinometers were sheared. (figs 2,3,4)

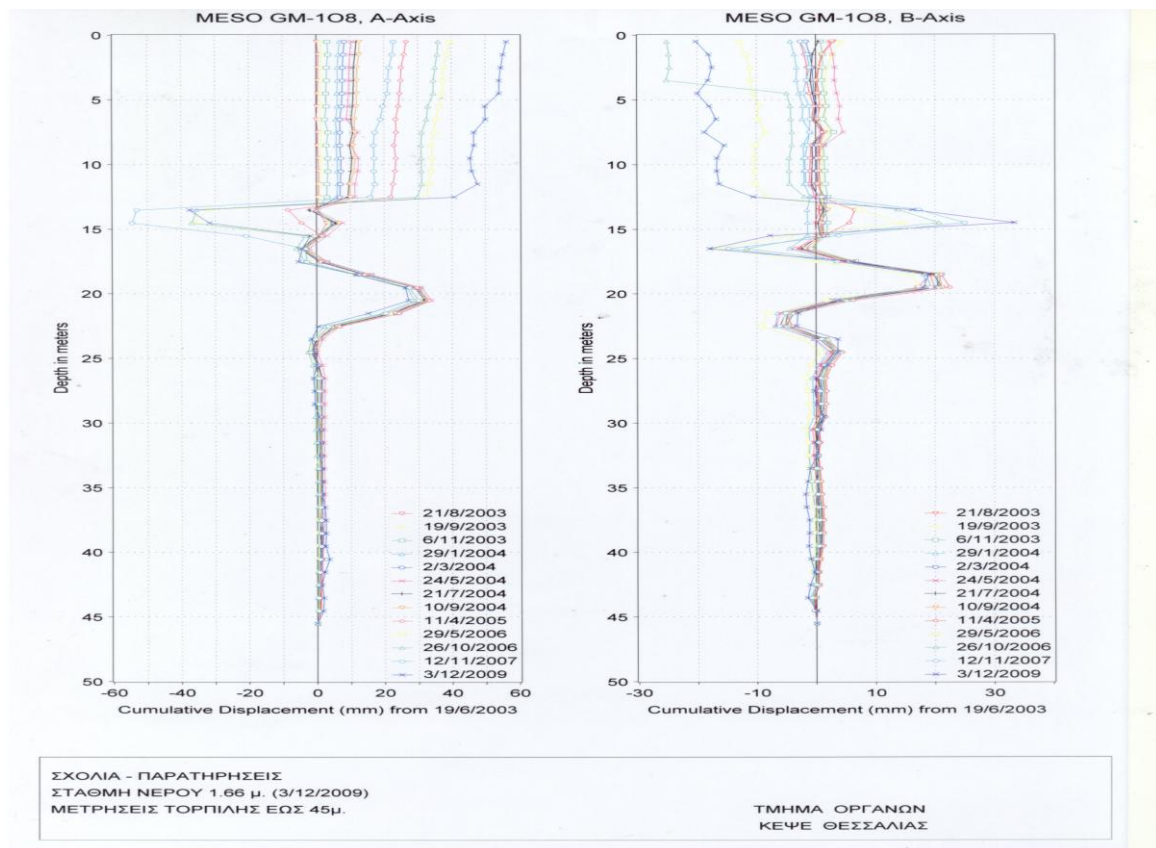
Figure 4 . Mesochora village sheared inclinometer (sector D)

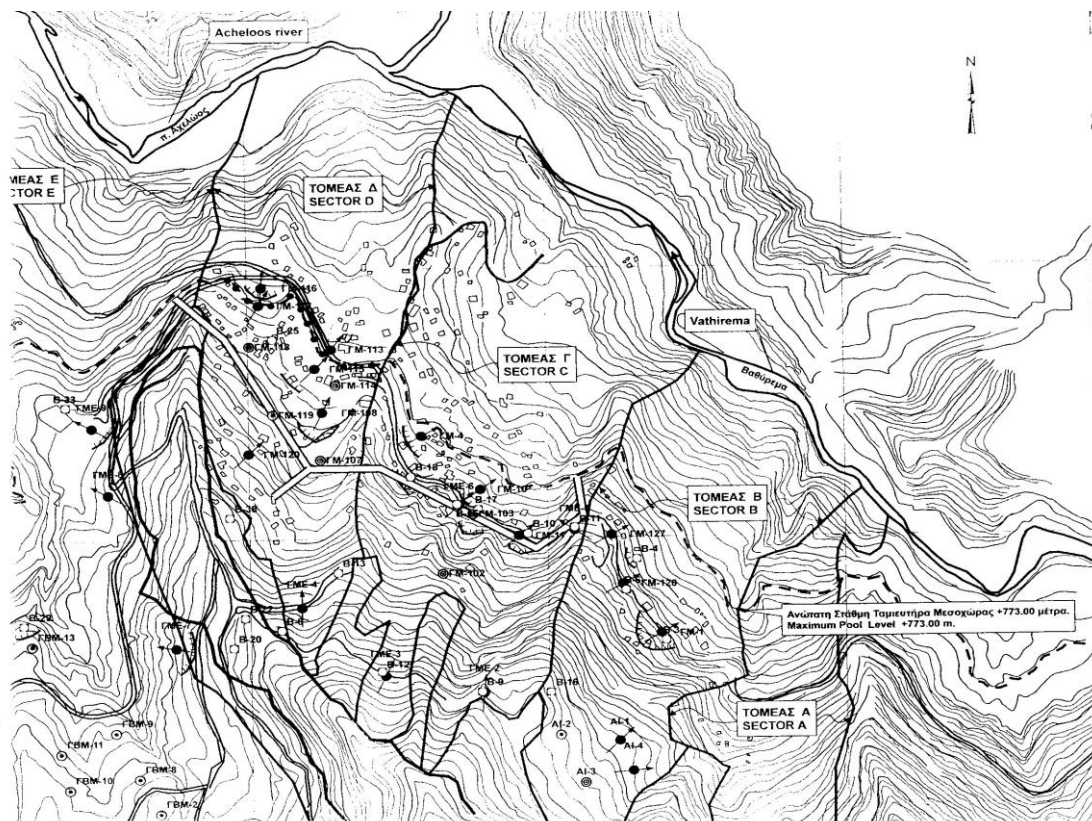
Figure 5. Mesochora village instrumentation-examined stabilization measures-scale 1:10000

In sector D ,where is the main village portion, the drainage of the slope by a

drainage gallery along with a reinforced concrete pile wall -of depth ranging between 10 to 30m- considered to be constructed 10 m higher of the maximum power pool level.(figs 1,5)
